Restoration of opencast mining sites

Welsh Parliament Climate Change, Environment, and Infrastructure Committee Restoration of opencast mining sites August 2024

Re: East Pit Opencast Coal site, Gwauncaegurwen. Subsidence damage to 36 Ochrywaun, Cwmllynfell.

Schedule of events – damage to 36 Ochrywaun Cwmllynfell – October 2017 to June 2019

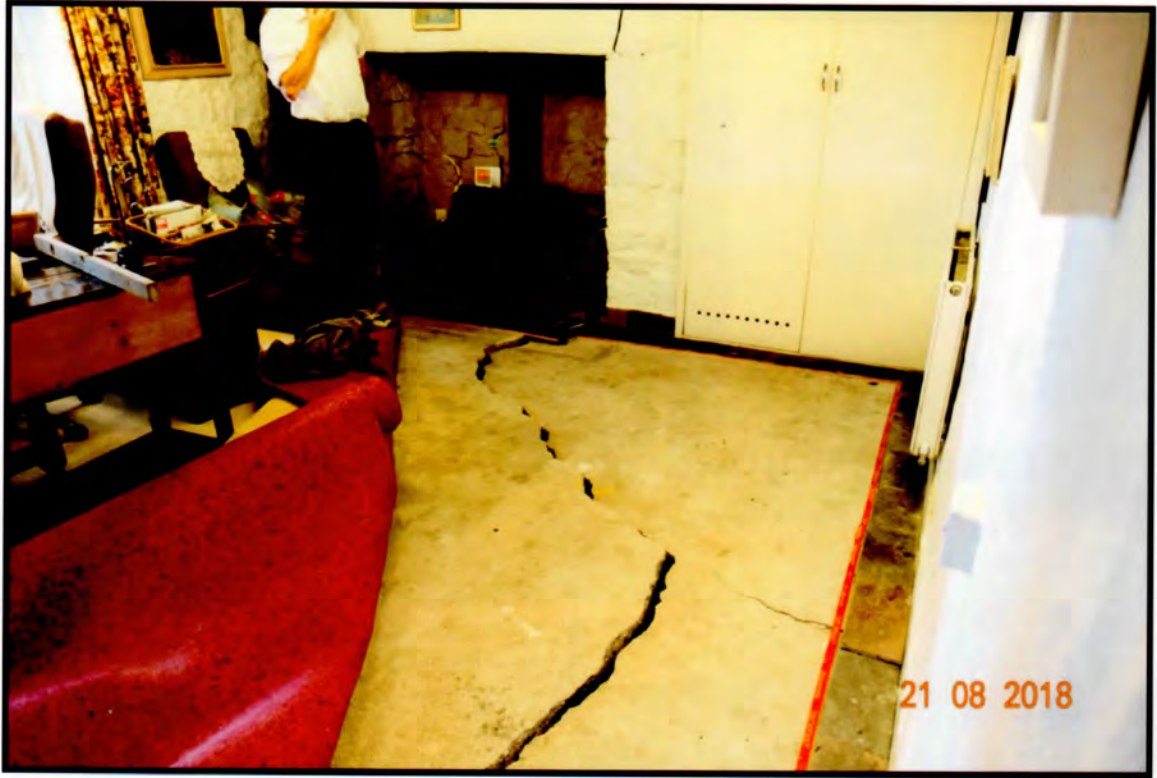
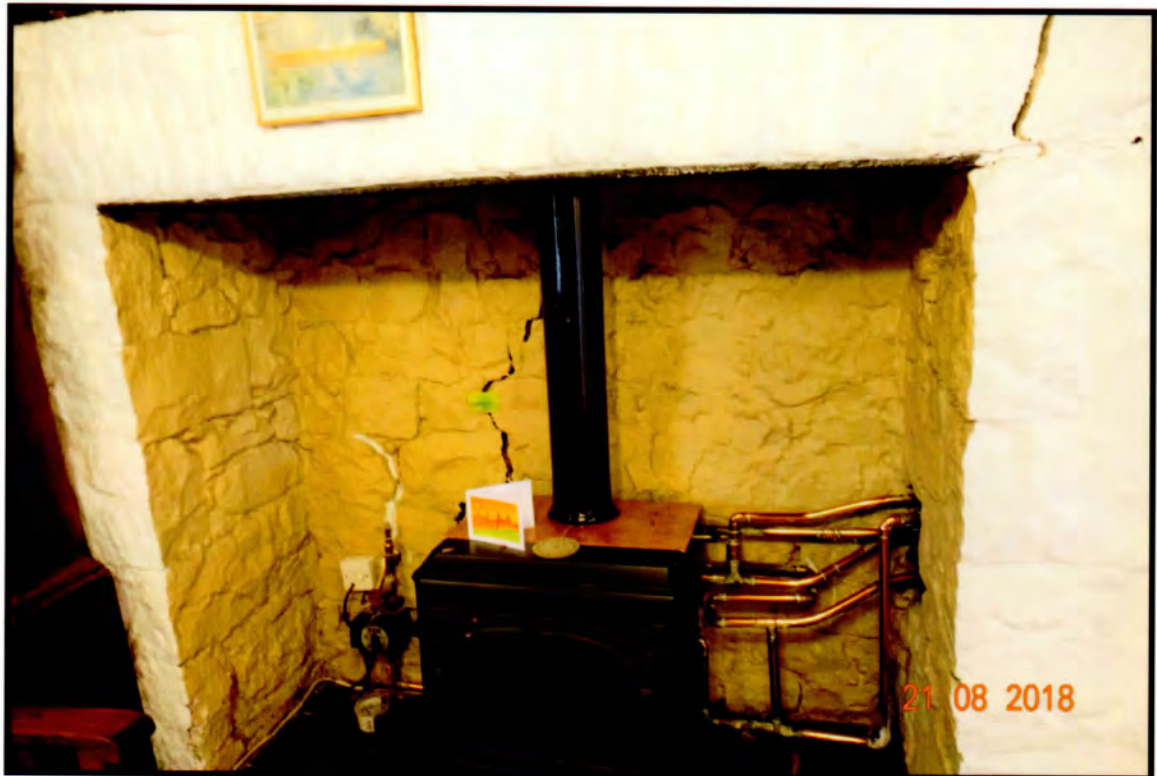
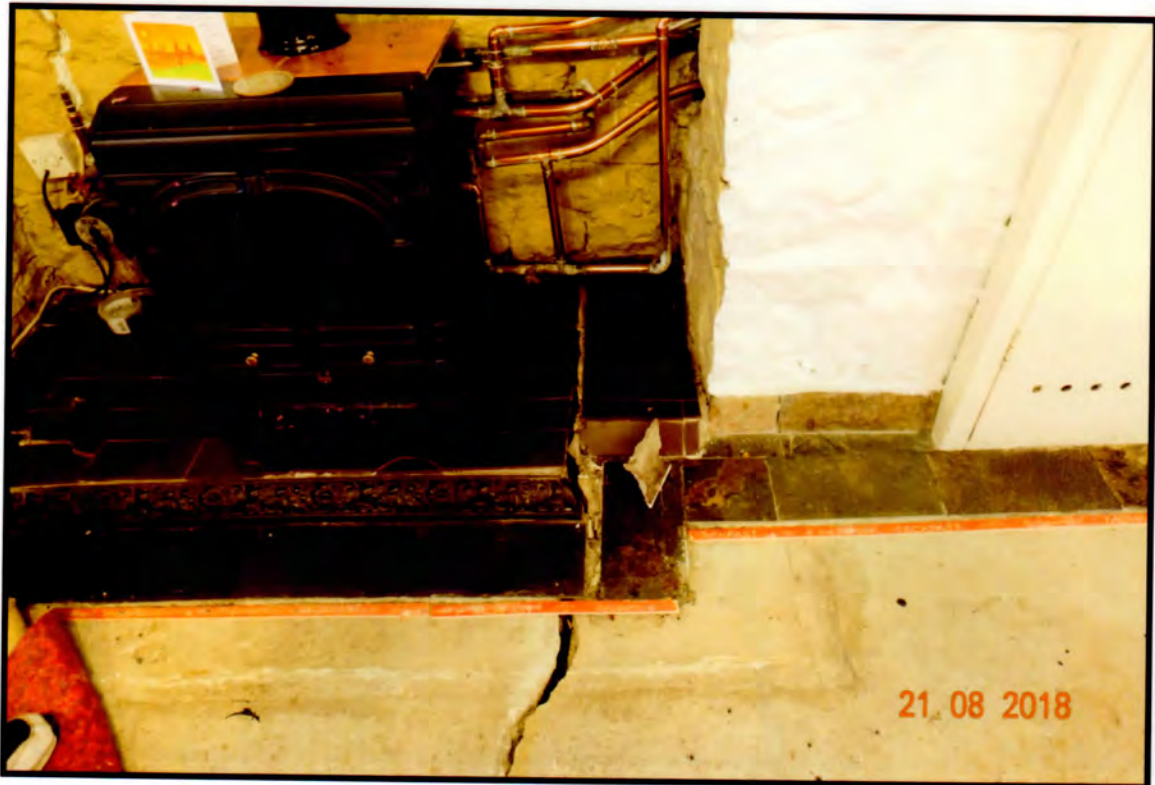
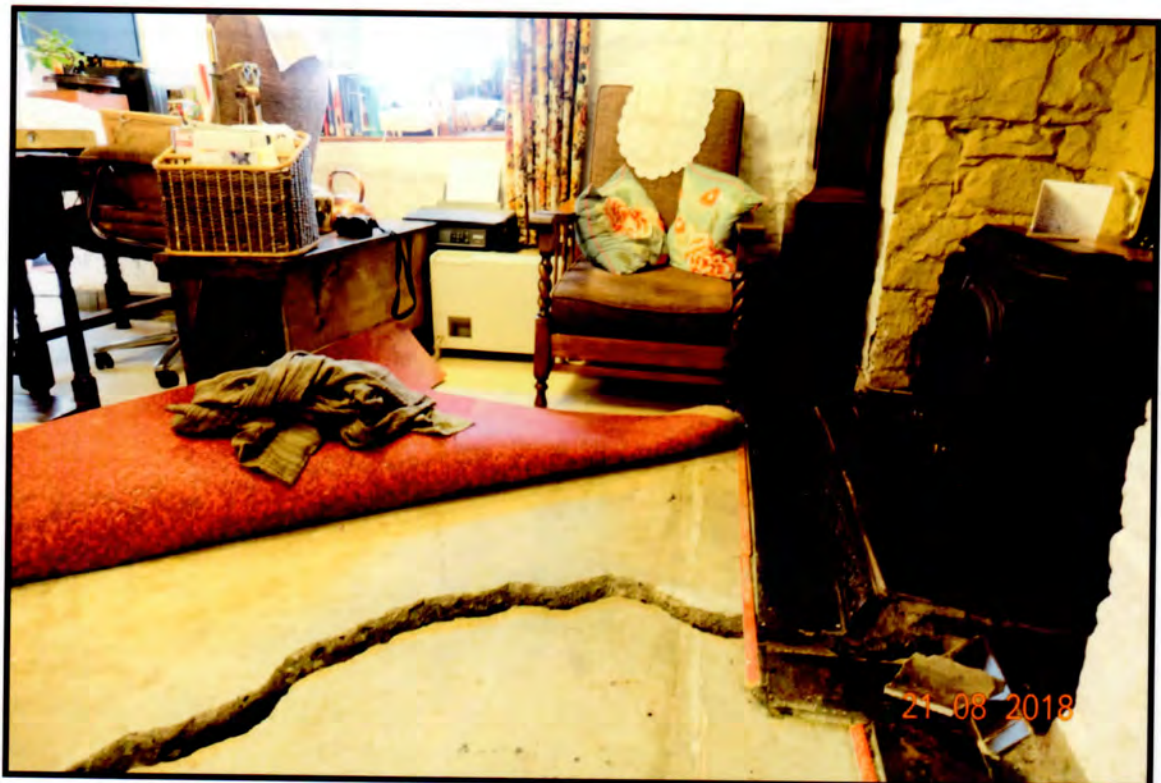
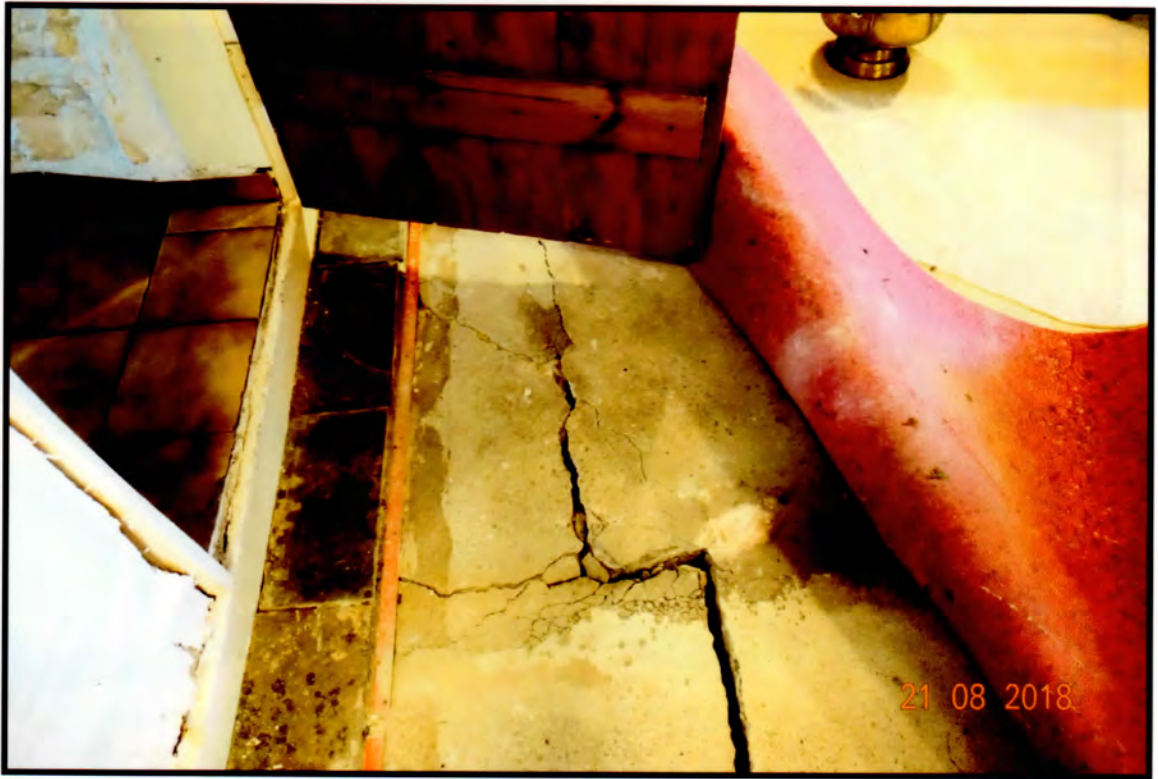
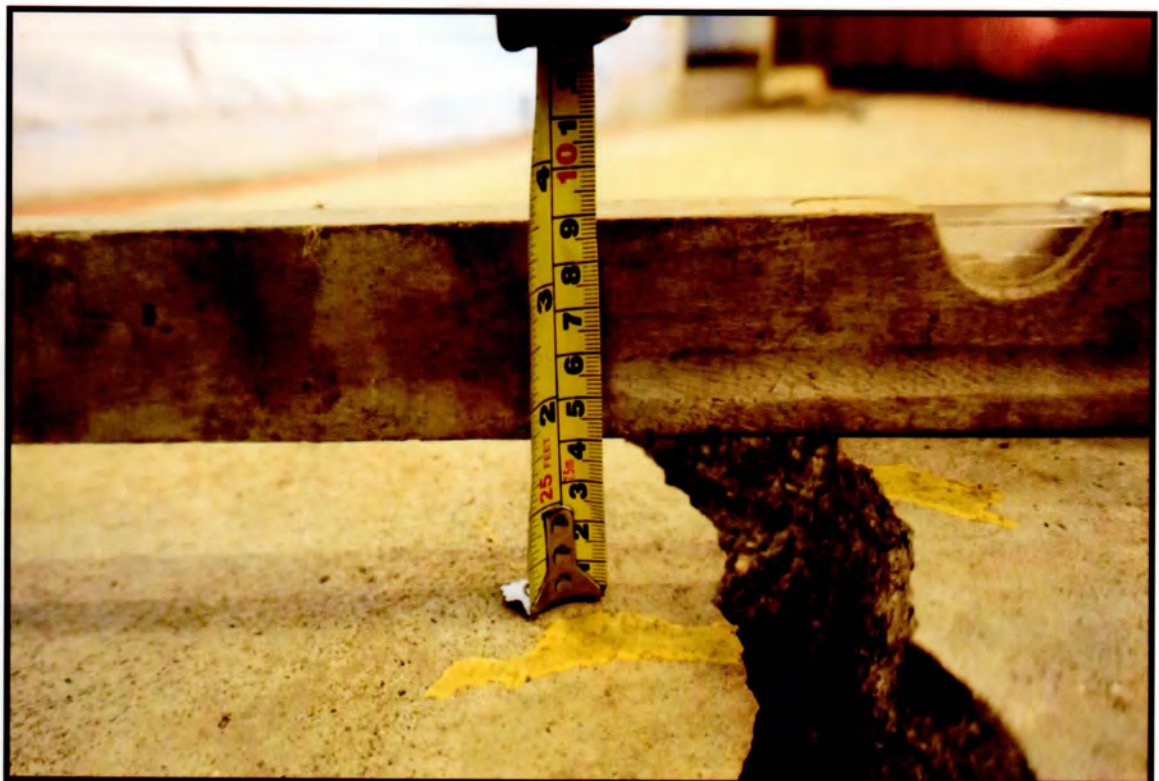
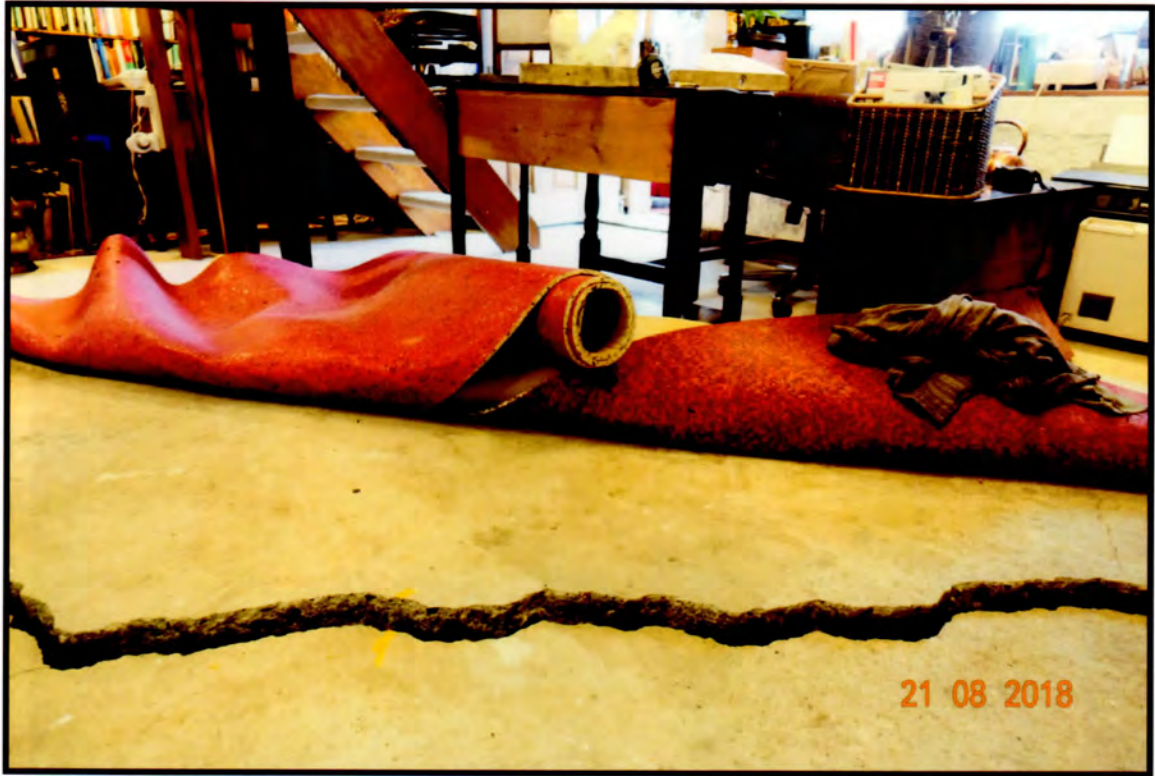
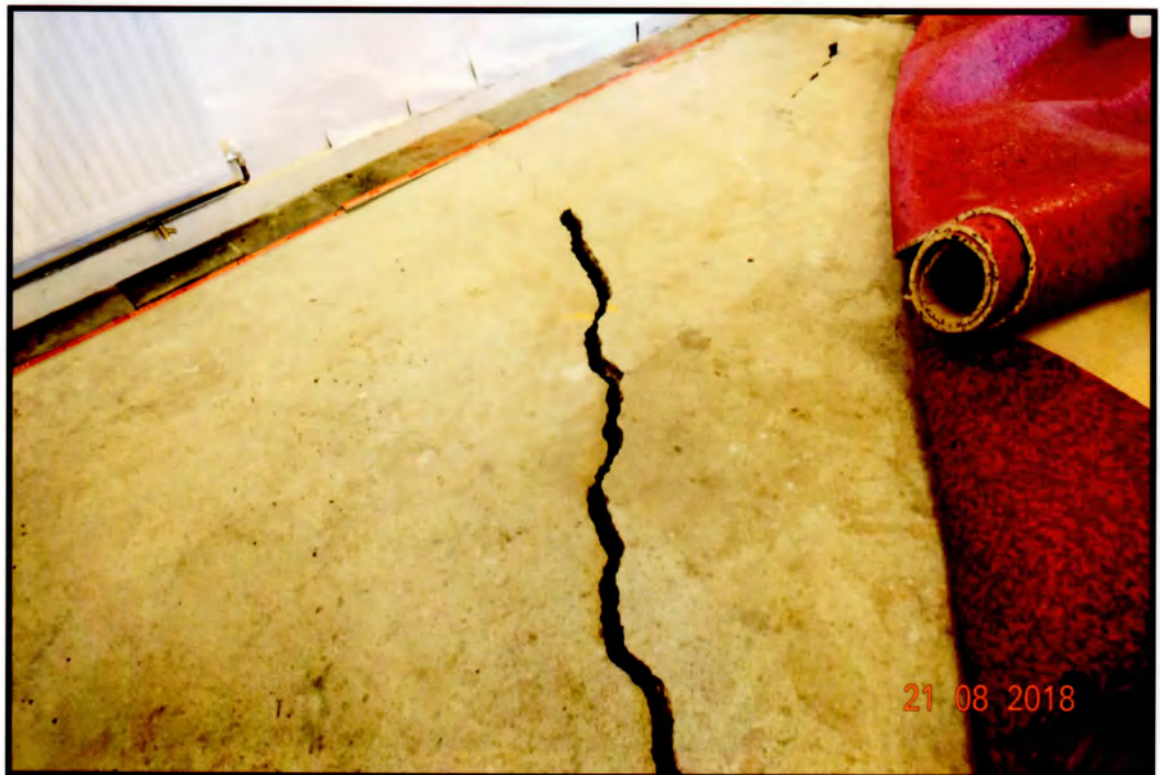
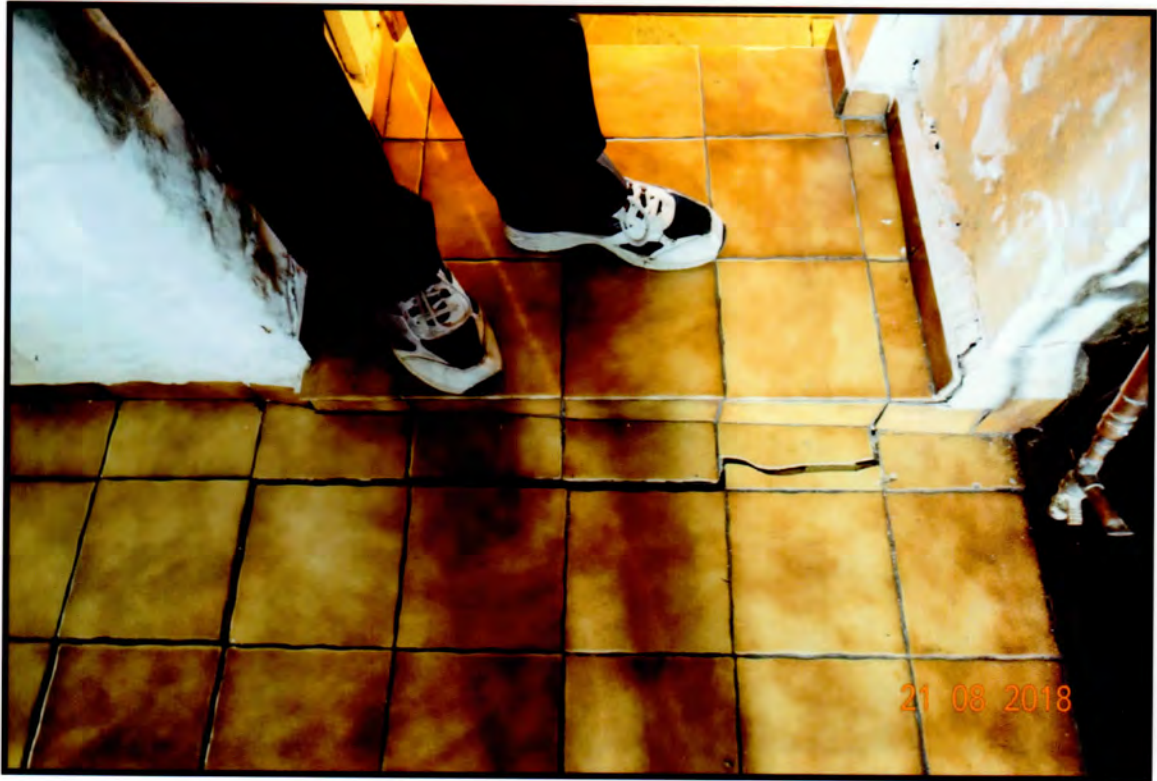
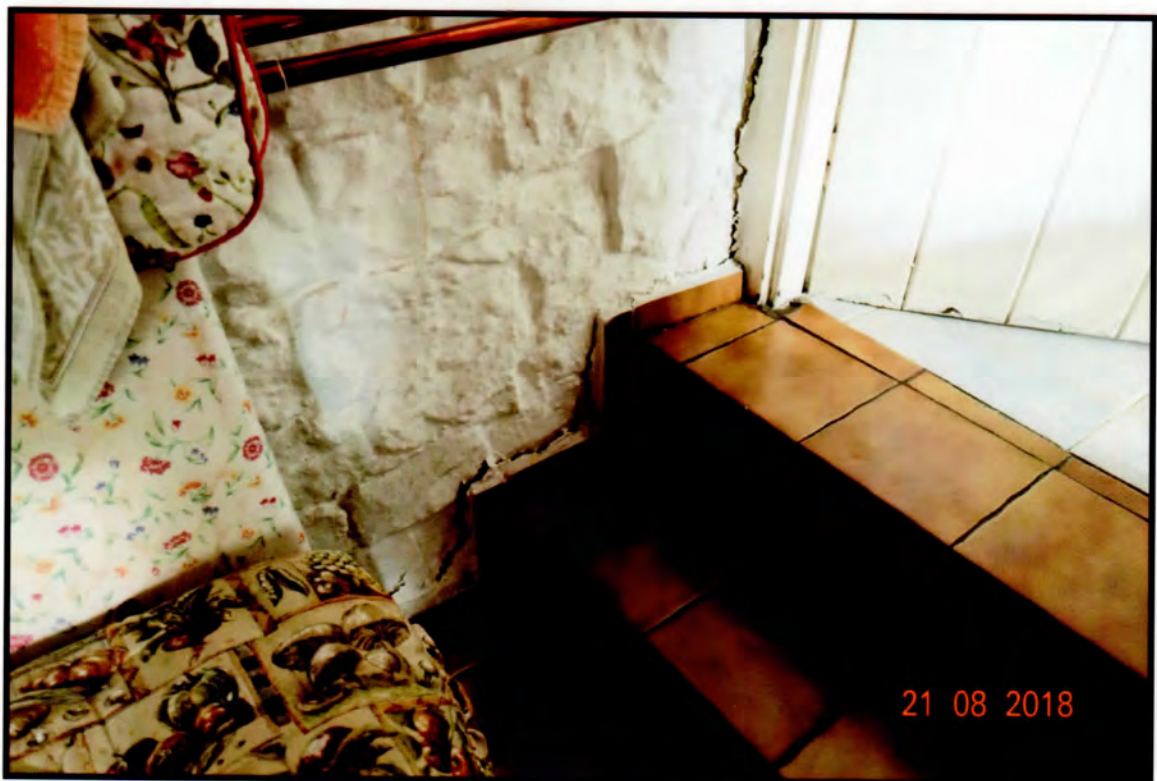
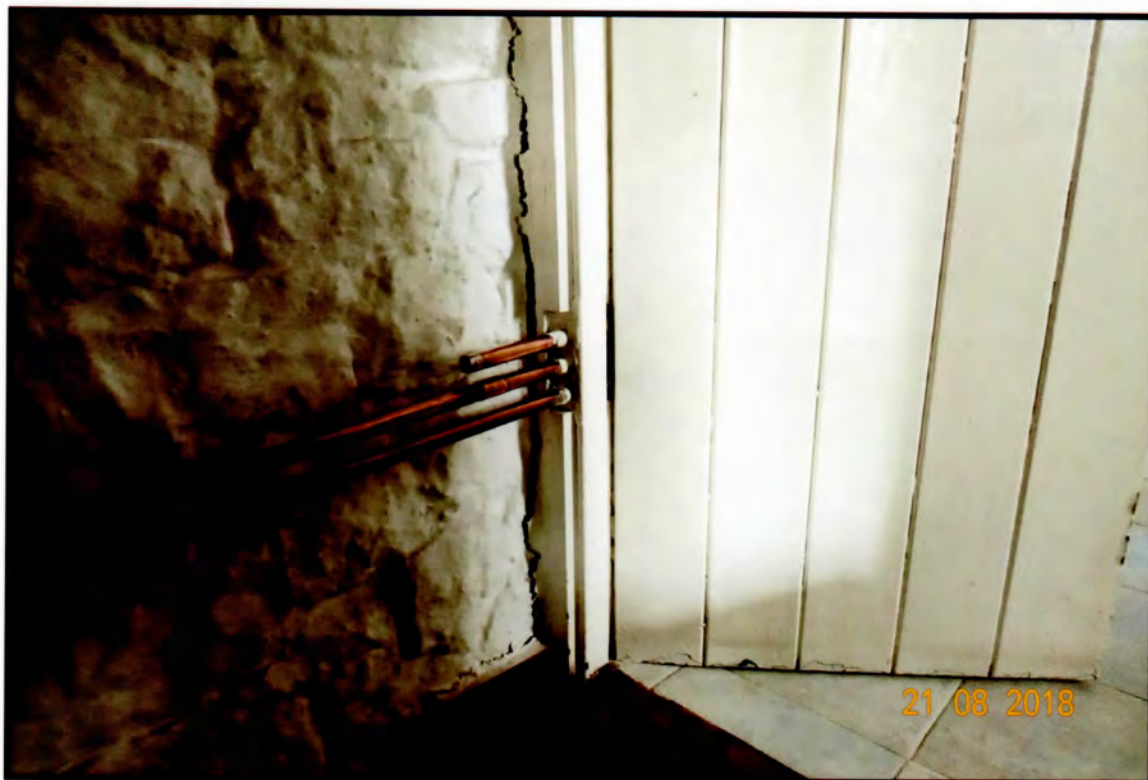
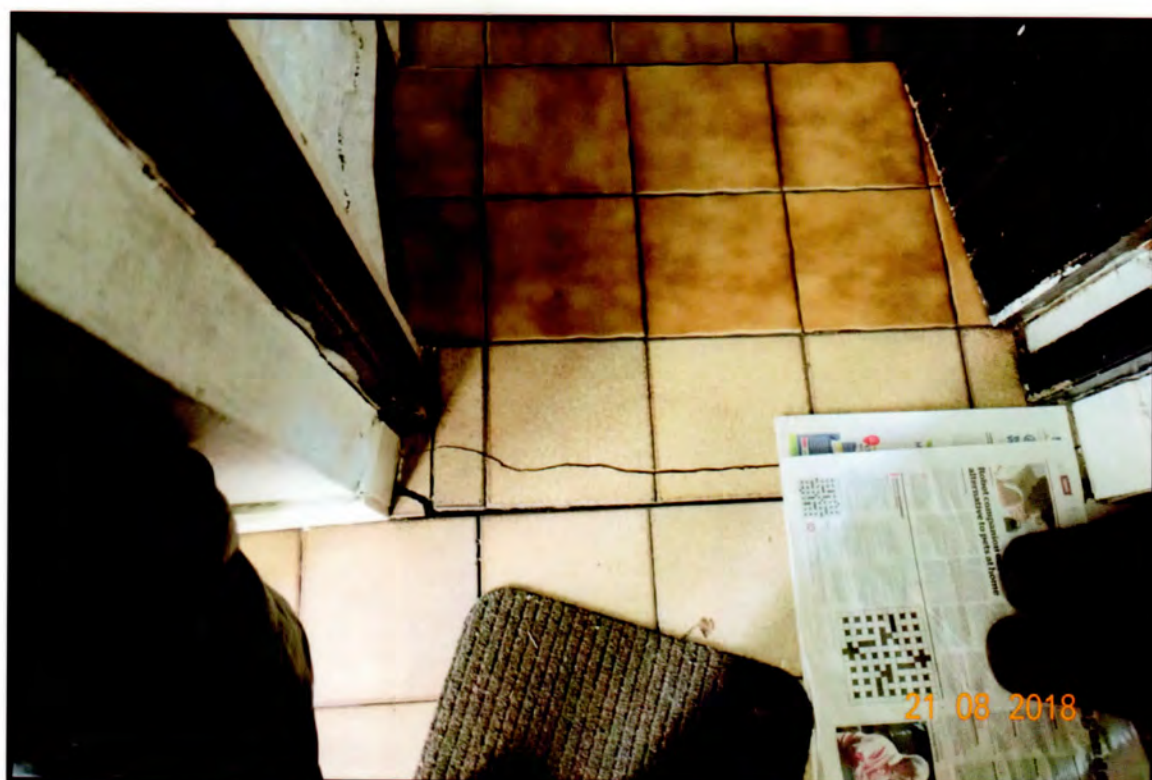
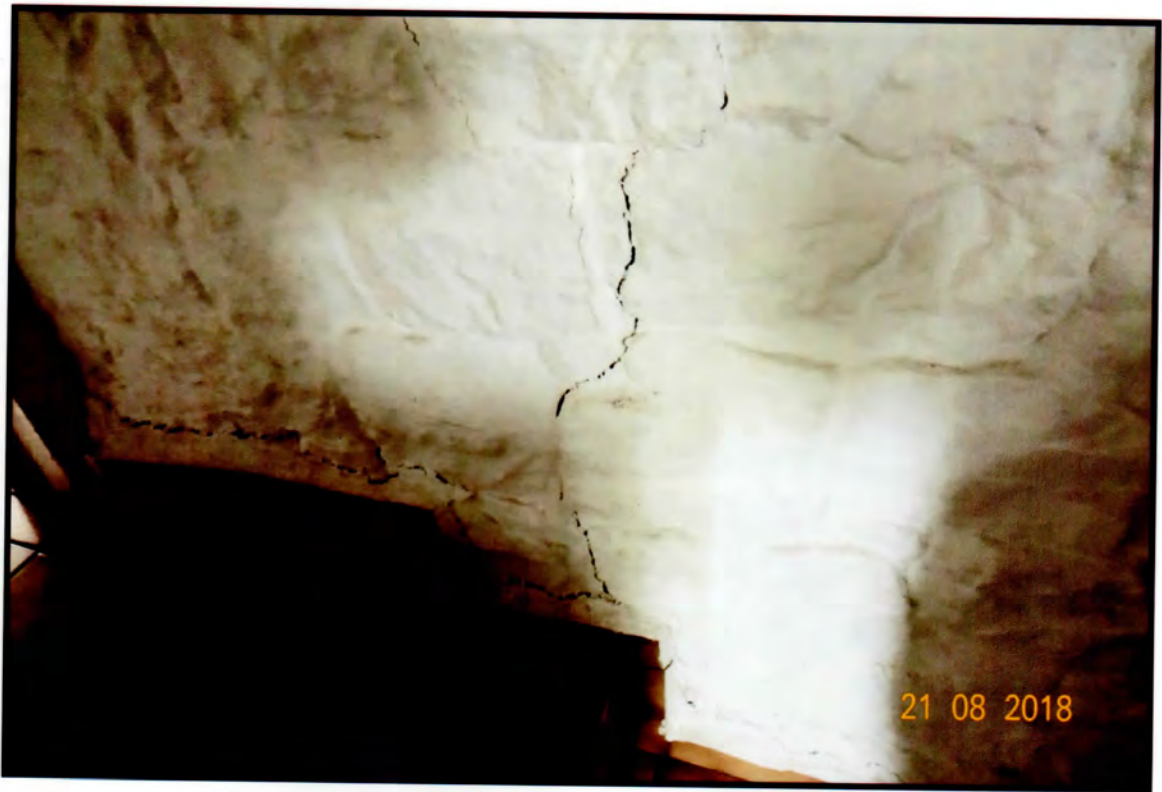
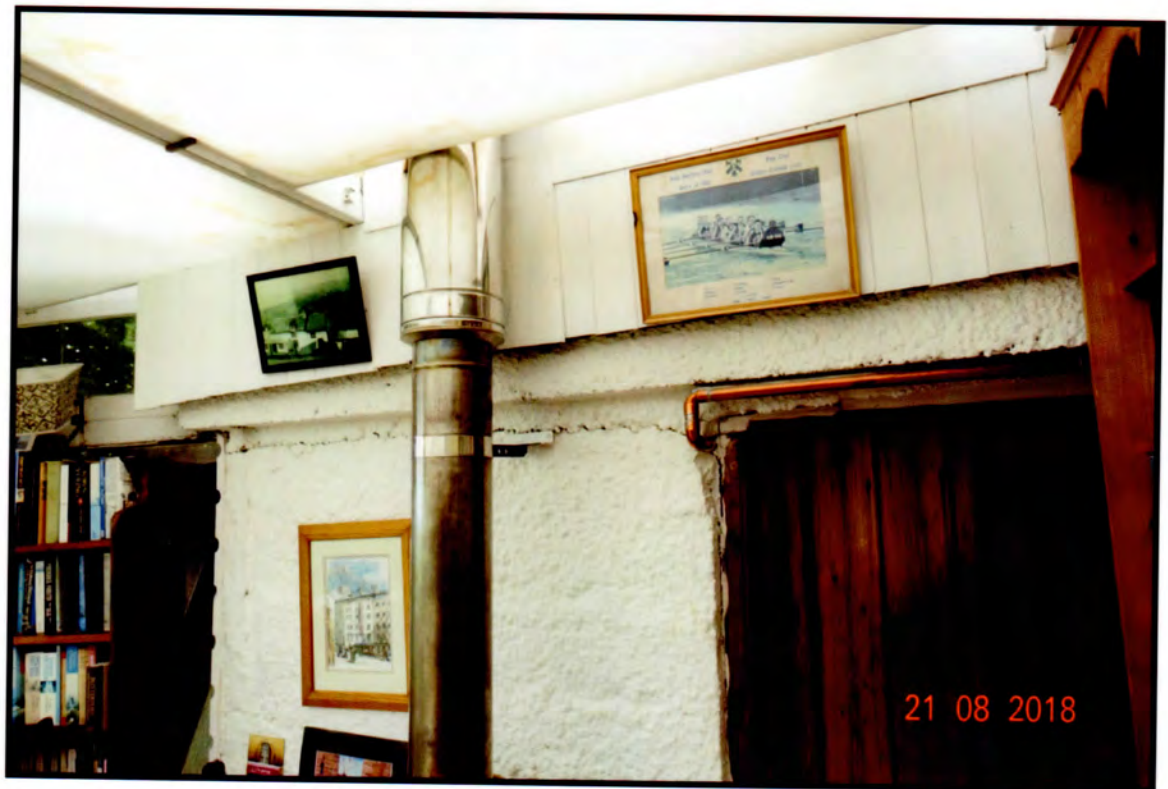
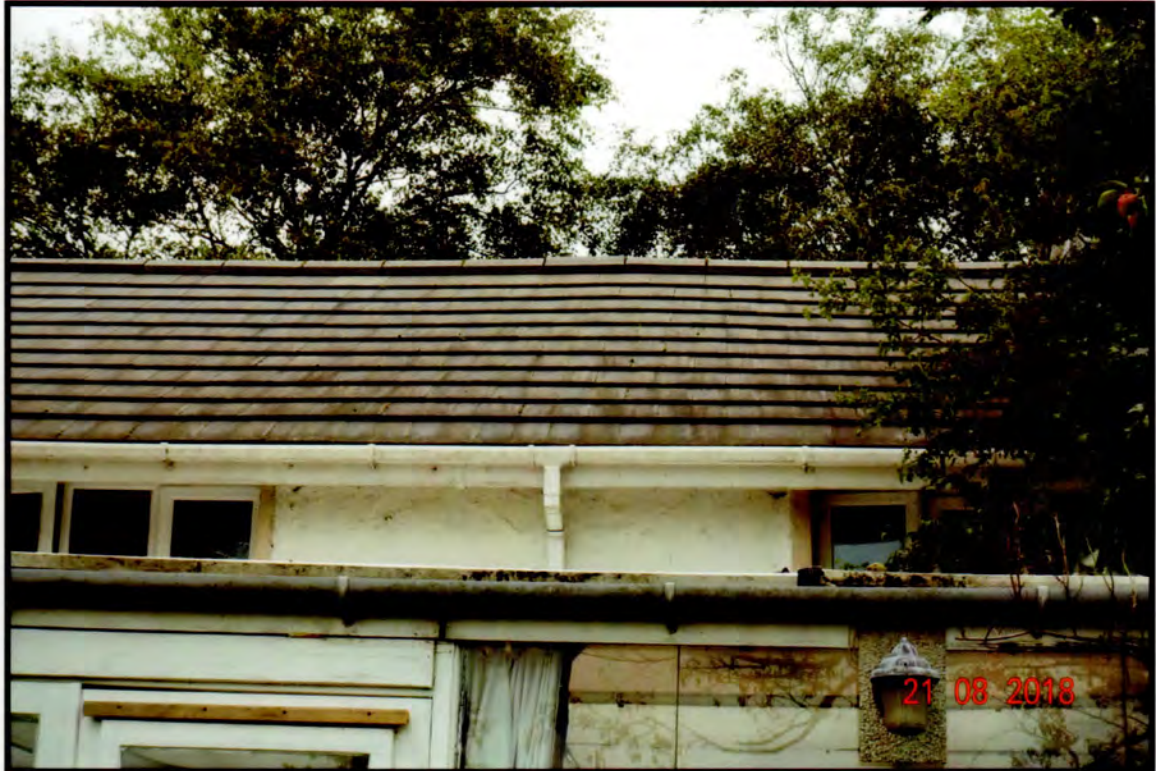
36 Ochrywaun Cwmllynfell
Photographs Taken 21st August 2018

My analysis initially of the cause of the damage, was the removal of lateral support to ground that collapsed in a landslip as a consequence. Blasting caused vibration of the weakened material and relative movement – subsidence - between parts of the structure of the property caused most of the damage listed in the original Damage Notice. The slumping of the surface deposits noted by CE following their removal of that lateral support, believed to be in late 2015/early 2016, was clearly the cause of that, and the time-related nature of that ground failure is typical of such events. The delay – of over a year – between the event and the effect reaching the Jordans' home and causing significant damage, is a reflection of the distance – nearly 200m - that the ground failure had to cover.

Mr Jordan installed a makeshift tell-tale on the wall where the fault line passes through the lounge hearth, and that suggests movement is currently at the rate of over 5mm/month between those two segments alone. The lounge floor fracture is 40mm wide and about the same vertical displacement (see photo). I am advised that this is some 10mm more than six weeks ago. This fracture was completely absent in December 2017 when I carried out my first survey, and when CE performed theirs.

The scale of the damage is massive, with a stream of secondary effects already recorded, such as water main, foul drain and plumbing failures. The upwards propagation of the fracture through the property has reached the roof line, where both roof and ridge are visibly displaced. There are at least a dozen vertical cracks in the south east elevation wall above ground floor window head level (in the conservatory). The upstairs stud partitions are giving way as they take the roof loads, with one roof truss being lifted out of its sockets.

My analysis of this is that blasting is now only a minor part of the problem. Solifluction, once started, is dependent only upon the nature of the ground and the particular conditions that pertain, of which supply of water as lubricant is possibly the most important. Mr Jordan is aware of this and has been very concerned about the levels of rainfall since the end of the dry summer. A watercourse passes between Nrs 37 and 38, and has been dry for some time, despite being fed by an unrepaired fracture in Ochrywaun's 100mm water main. That watercourse appears to be in boulder clay.

The apparent acceleration of the movement in their home may well be a consequence of the recent weather; its underlying and fundamental cause however remains that removal of support by CE.

In the light of this, and CE's refusal to even inspect the Jordans' property, I am requesting that you take immediate action to investigate, and to propose and implement a repair scheme for upper Ochrywaun. I don't think it is possible to repair Nr36 without an effective scheme to stop the solifluction movement, and that is best done on a scale that encompasses all the affected property. CE are dumping spoil on the toe of the landslip, working from south to north, but this can have no beneficial effect, even if they have designed it to stop the toe of the landslip moving further. Mr Jordan has had no replies to requests for information from any of the parties, so can only speculate upon what he can see happening. Spoil dumping per se will not reverse the solifluction process on the Jordans' property, nor even in the short term, stop it.

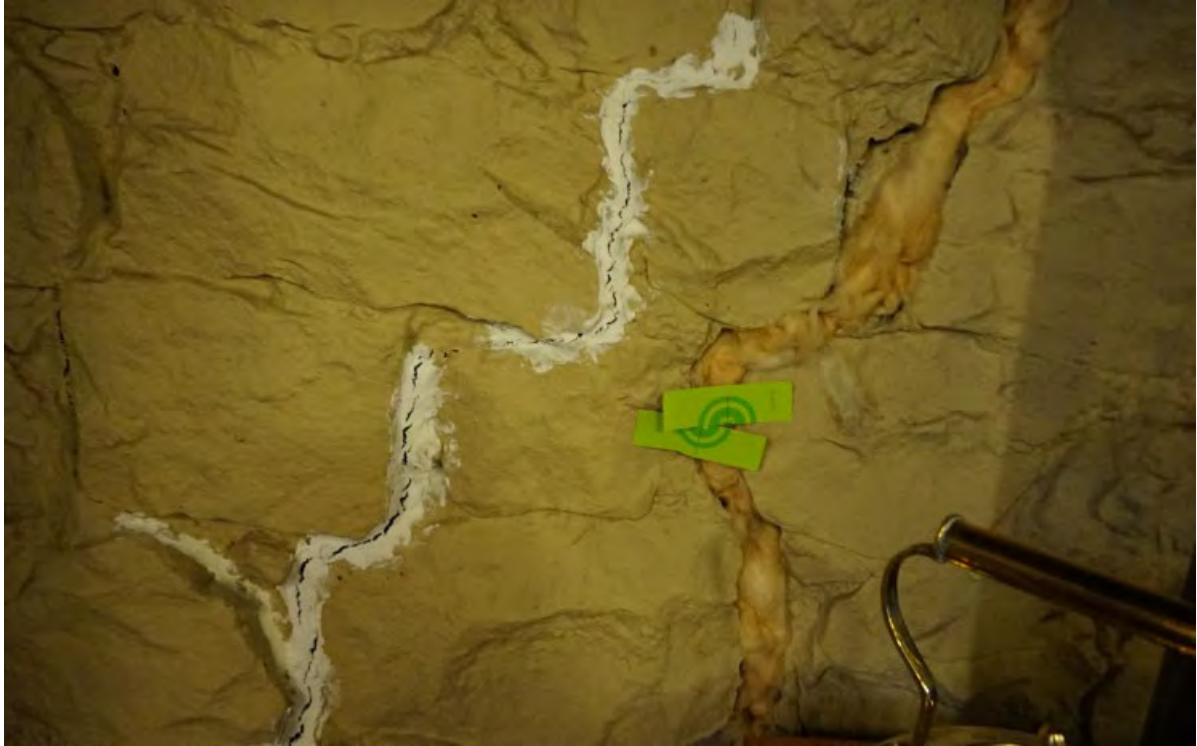
The second (of three that will develop) fracture in the fireplace back wall, has reopened after being filled

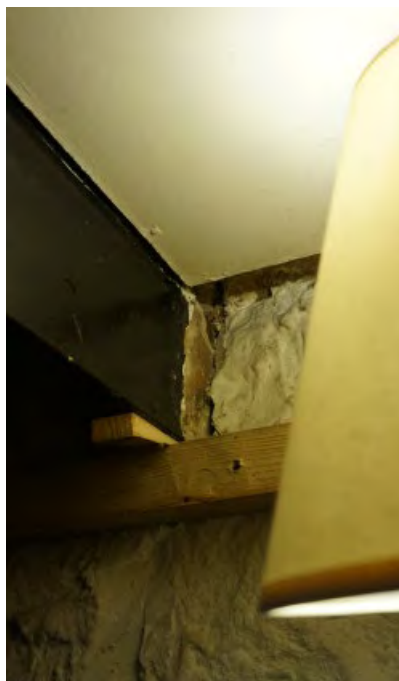
One joist end is out of its socket and supported on a temporary bearer

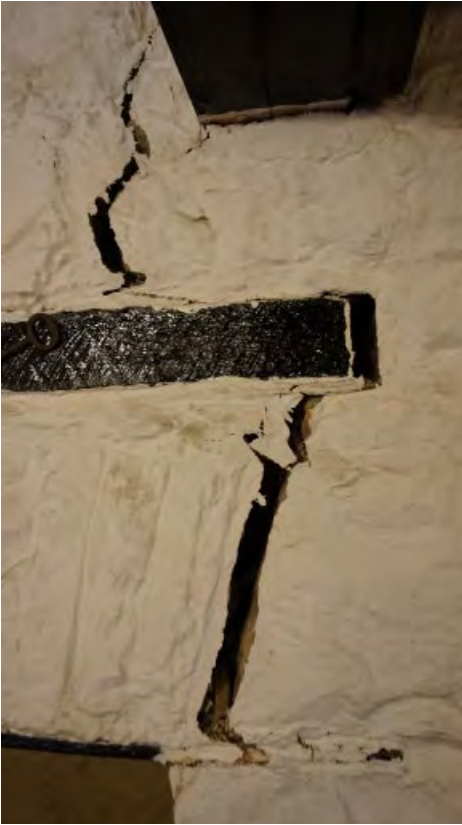
The fireplace arch and relieving beam are coming off their bearings

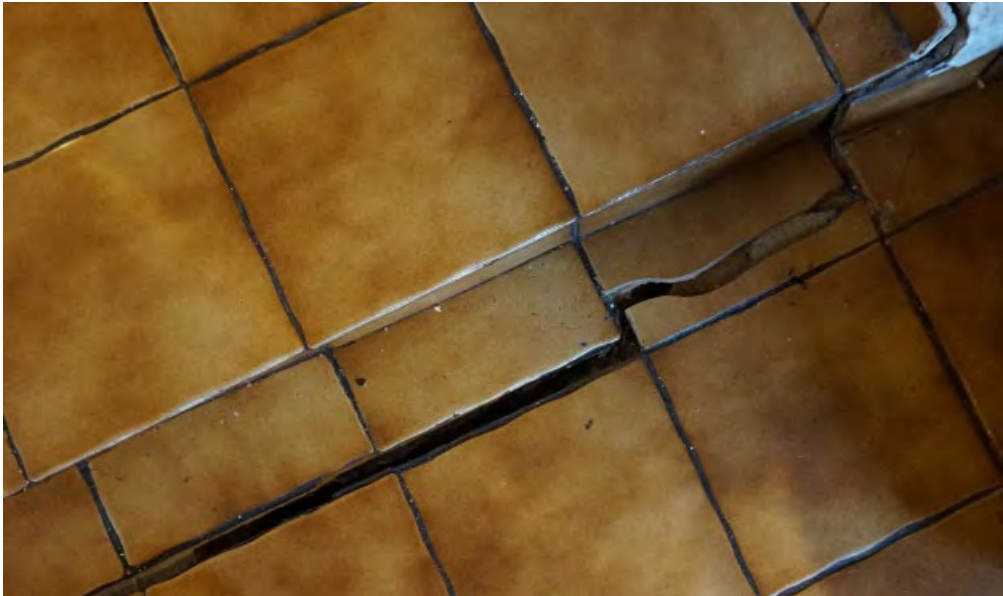
The kitchen floor is coming apart

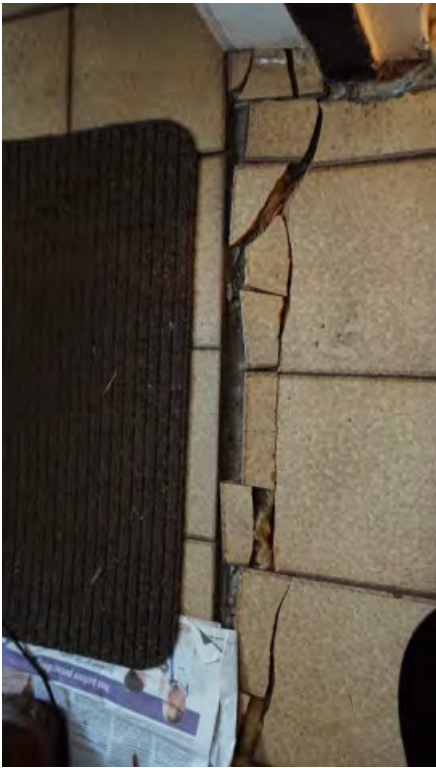
The porch/kitchen floor joint is shearing as the house moves

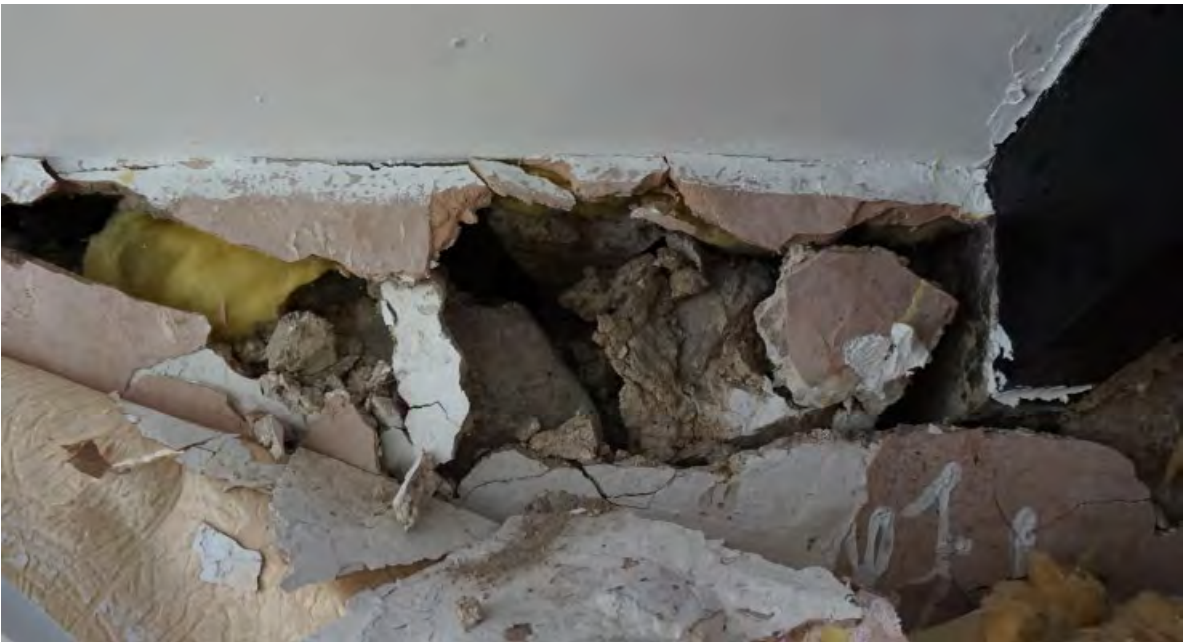
The roof truss has destroyed the wall as it pulls off its bearing

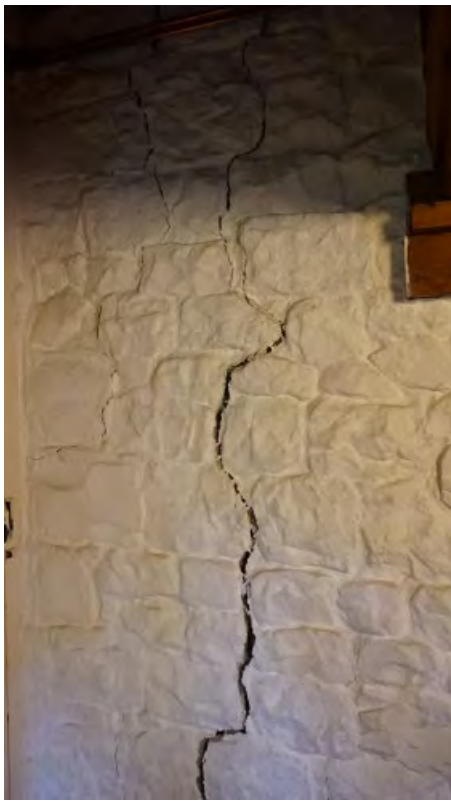
A shear plane develops in the kitchen wall

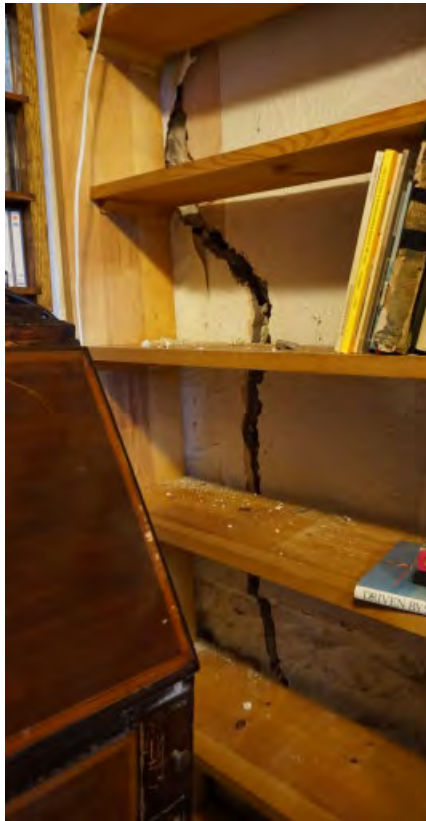
And the quoin is isolated by a second shear plane in the NE pine end

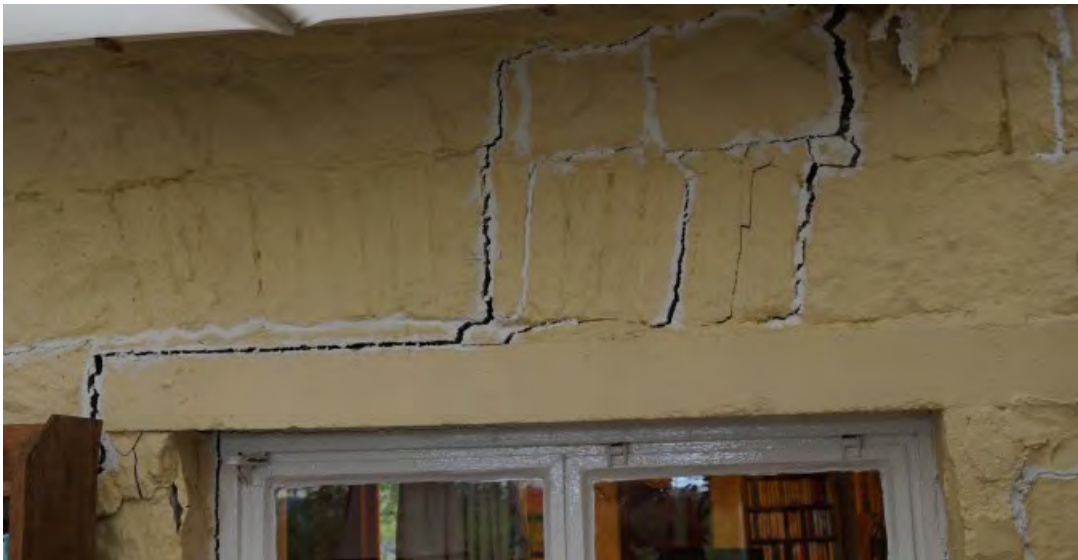
The SE house wall fractures for a third time over the window head

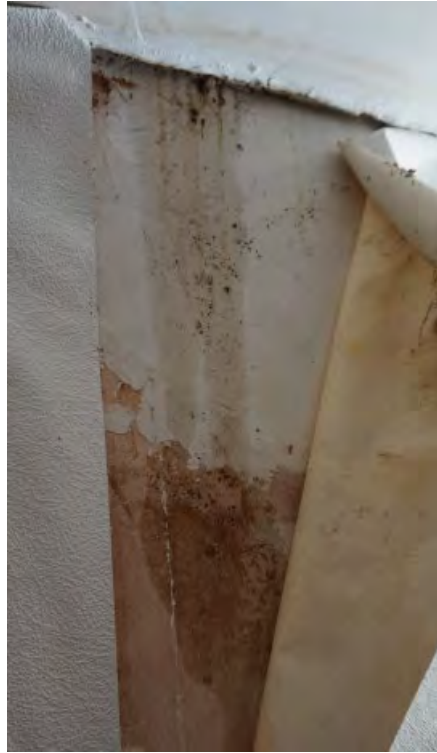
The chimney has pulled over and opened the flashings to let the rain in

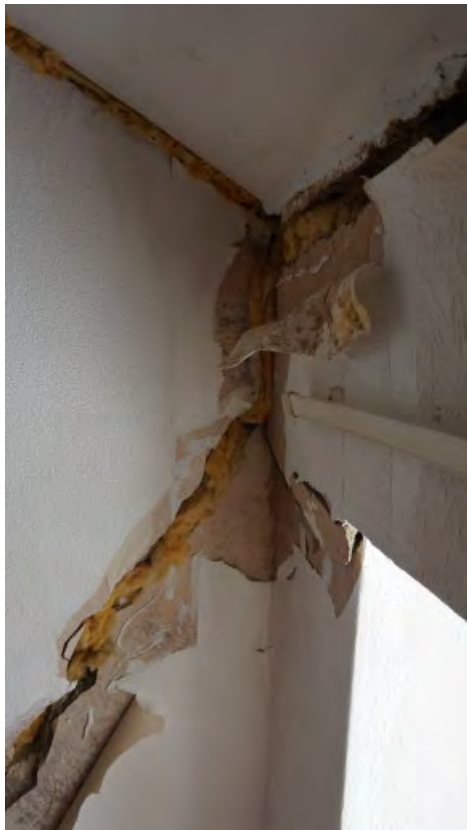
The NE and SE external walls part company at eaves

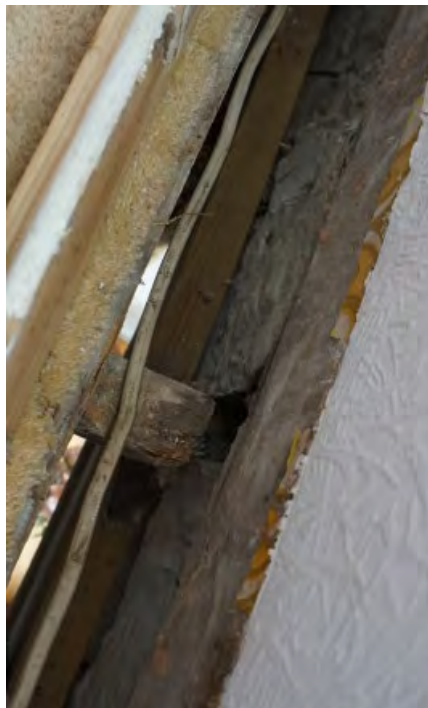
The first floor joist is fully off its wall bearing

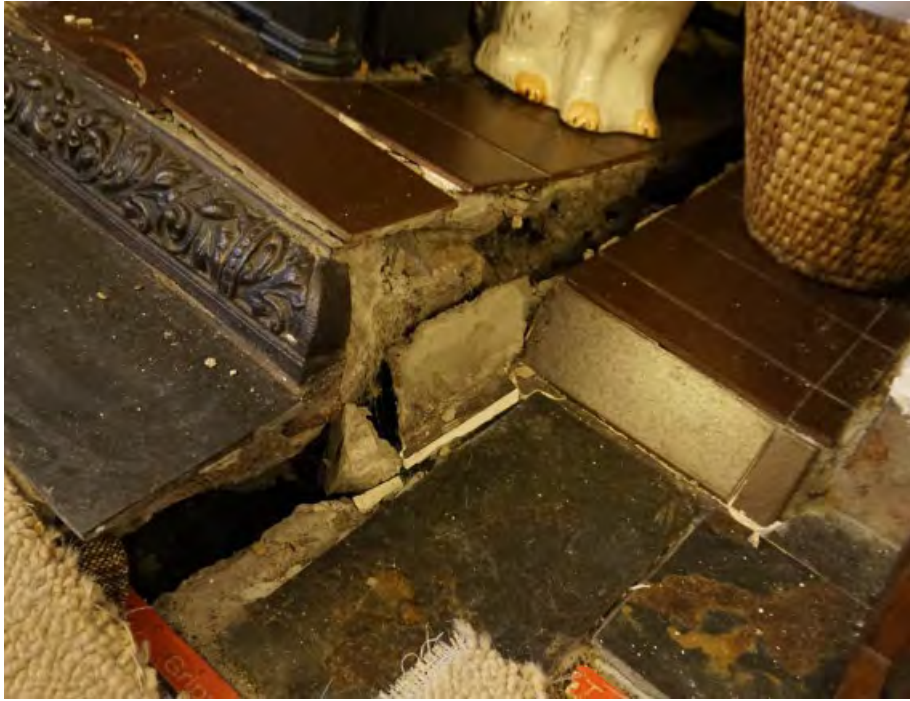
The hearth is destroyed

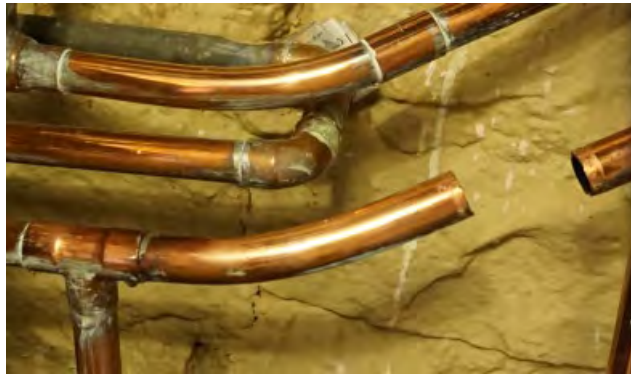
The heating pipework pulled apart
